# ACOUSTIK ACOUSTICAL PERFORMANCE TEST REPORT

ASTM E90 AND ASTM E492 TESTING ON 8 DALTILE PORCELAIN TILE OVER  
2 MM ACOUSTIK RUBBER UNDERLAYMENT

Concrete Slab - 203 mm

R5380.13-113-11-R0

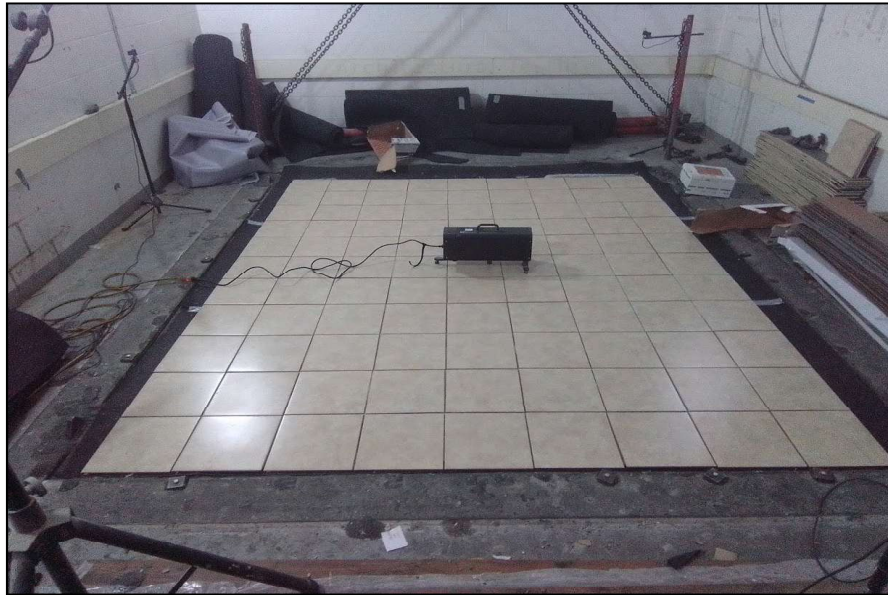
**Photo No. 1****Source Room View of Test Specimen Installation**

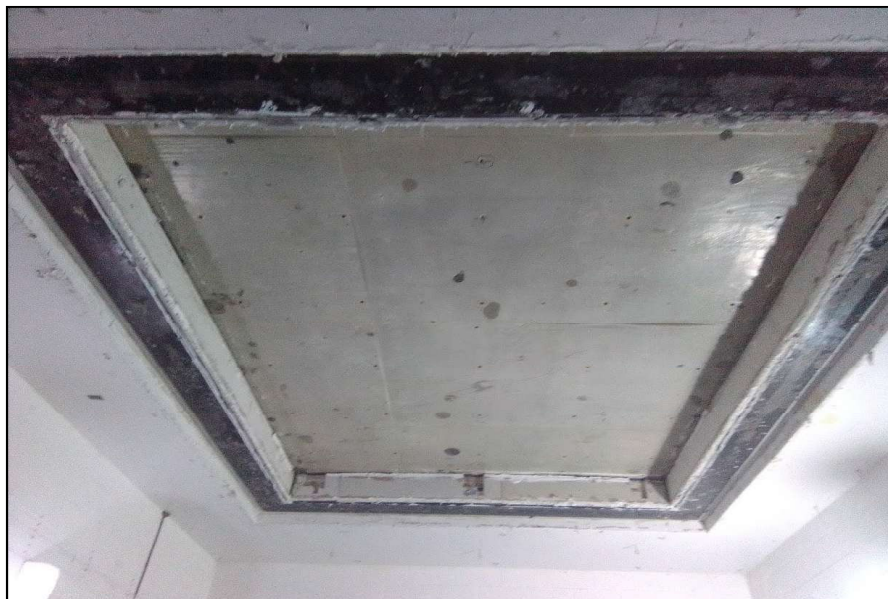
**Photo No. 2****Receive Room View of Test Specimen Installation**
